Quantifying the image quality of the KDC-10 refuelling vision system

TNO Human Factors Research Institute

4 December 1996

TM-96-A052

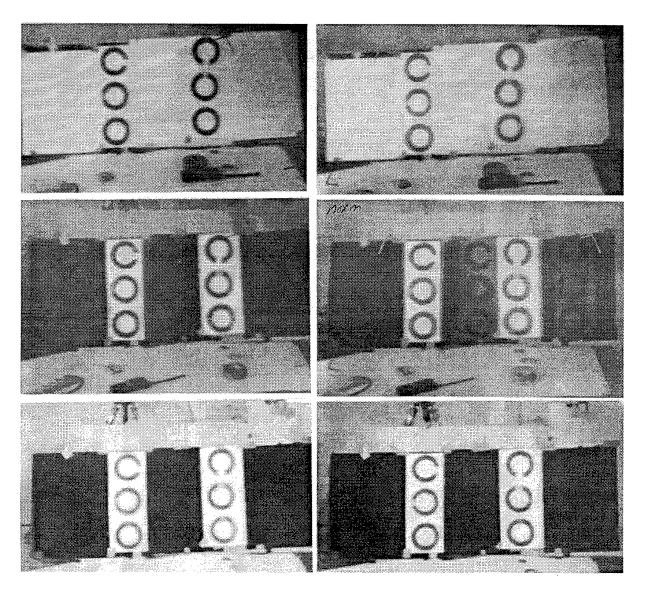
Fig. 1 Pictures taken of the RVS image from the position of the boom operator. Shown are two 20 cm TNO contrast charts. *Left:* the left camera view. *Right:* the right camera view. *Top:* the stereoscopic mode with white surrounding the test charts. *Middle:* the stereoscopic mode with black surrounding the test charts. *Bottom:* the monocular mode. The system setting for each is NOR-MAL with auto-iris. The stereoscopic crosstalk is visible as a ghost-image of the test charts.

The aforementioned crosstalk is clearly visible as a ghost image. Crosstalk is defined as the luminance 'leakage' of the right channel image into the left channel, and vice versa. In order to quantify the level of crosstalk, a stereoscopic test battery was set up in the laboratory. A Silicon Graphics Onyx generated test patterns, presented on a 19" Tectronix monitor with a NuVision 3 segment stereo-shutter. This shutter is not exactly the same as the one used in the RARO RVS (2 segment screen?). According to Bos (1993) a 3 segment shutter is slightly better than a 2 segment shutter. The test pattern consisted of a large black field in one image and red, green, blue, and white strips in the other. If the shutter worked perfectly, one eye should see nothing (black) and the other the colored pattern. The amount of light shining through in the "black" image therefore defines the level of crosstalk. The luminances were measured with a LMT photometer at the vertical middle of the screen. The results with the black image in the left and right channel are shown in Table III. The crosstalk is significant and asymmetric between the two channels: 9.3% and 19.6% for white. The right eye channel is more degraded. Of the three colors red is relatively little affected by crosstalk (5.4% and 16.8%) and blue the most (14.2% and 22.7%). The effect of the crosstalk on the contrast in an actual image can then be calculated according to the formula

The leakage of the stereoscopic screen causes significant reduction in image contrast, in particular for dark objects on a white surround. The relevant location of the "surround" is 50 cm to the left and right of the object for the right and left eye views. A receptacle placed more than 50 cm from the edge of the receiving aircraft will suffer less from the crosstalk than a receptacle placed at the side of the aircraft. Due to the asymmetric nature of the crosstalk, a receptacle on the one side should be more visible than on the other side. Crosstalk may be minimized with a better screen and faster, so-called "rare earth", phosphors. The calculations in Table IV and the results in Table V by how much the image contrast can in principle be improved in the "STEREO" mode.

- 3 Stereoscopic crosstalk may be reduced considerably by replacing the RVS monitors with fast-decay phosphor screens and by updating the stereoscopic screen. We advice to first quantitative confirm the improvement before implementing such a change.
